Natural Resources and Implementation Report for the Big River Management Area

Central Rhode Island

Rhode Island Chapter of Trout Unlimited (TU225) 203 Arcadia Road Hope Valley, Rhode Island 02832

EA Engineering, Science, and Technology, Inc., PBC 301 Metro Center Boulevard, Suite 102 Warwick, Rhode Island 02886

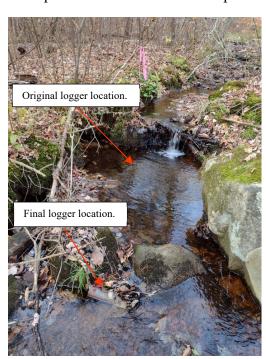
Displaced TU25 logger downstream of original location. Note the logger is partially out of the water.

During logger collection, loggers TU02, TU17, and TU25 were observed and retrieved at locations downstream of their original deployment location. In addition, the new downstream location of the loggers was observed to be impacted by siltation or debris. As such, these loggers contained inconsistent data, which when correlated with ambient air temperature data was determined to be representative of the logger being out of the water (either fully or partially). This is common with this form of logger deployment as heavy or significant rainfall events can result in flow surges in

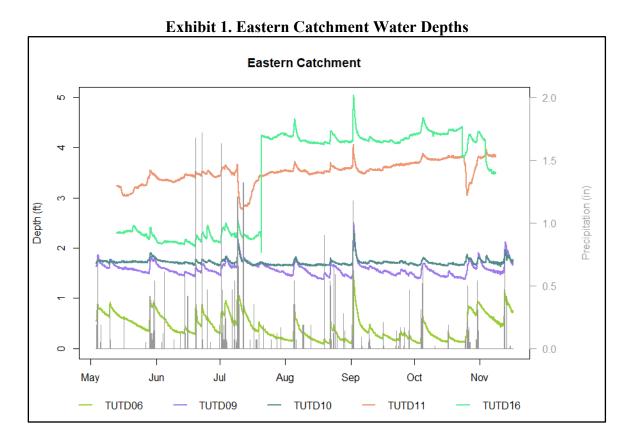
Exhibits 1-3 depict stream depth data collected by the 14 temperature/depth loggers installed from spring to fall 2021 in the eastern, northern, and western catchments. No temperature/depth loggers were deployed in the central catchment. The graphs also show daily rainfall data along the y-axis to compare water depth fluctuations with rainfall events.

Note that the TUTD16 logger in the eastern catchment appears to have shifted in mid-July but continued to reflect the representative fluctuations of water levels. This logger was deployed in Tarbox Pond with a static dam structure, so it is impossible that the water level in the impoundment dropped as indicated. The general hypothesis is that, since this logger was placed in a rocky area at depth, the logger could have inadvertently been placed on a submerged rock and then been dislodged from the top of the submerged rock during the study and come to rest at a more significant depth.

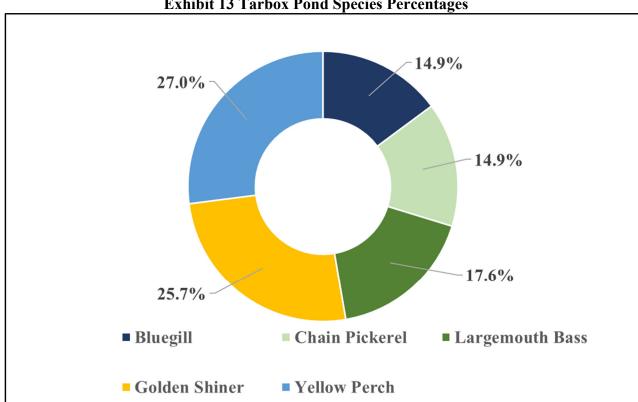
Exhibit 13 Tarbox Pond Species Percentages

The fishery survey from Tarbox Pond captured a total of 74 fish, including yellow perch, golden shiner, largemouth bass, chain pickerel, and bluegill (see Exhibit 13).

In Tarbox Pond a variety of warmwater species were caught (Exhibit 13). YOY individuals of both largemouth bass and chain pickerel were captured, and 36% of the largemouth bass population and 69% of chain pickerel were YOY. Both largemouth bass and chain pickerel are voracious predators and likely heavily predate on the other species observed in Tarbox Pond. Bluegills and golden shiners are especially at risk to predation due to each species' smaller size and the golden shiner's lack of defense mechanisms. Since largemouth bass and species of pickerel were observed in streams where brook trout were observed, they can present a risk to both juvenile and adult brook trout. No brook trout were found in the survey at Tarbox Pond, which is classified as a warmwater impoundment by RIDEM, and is characteristically unsuitable habitat for brook trout.

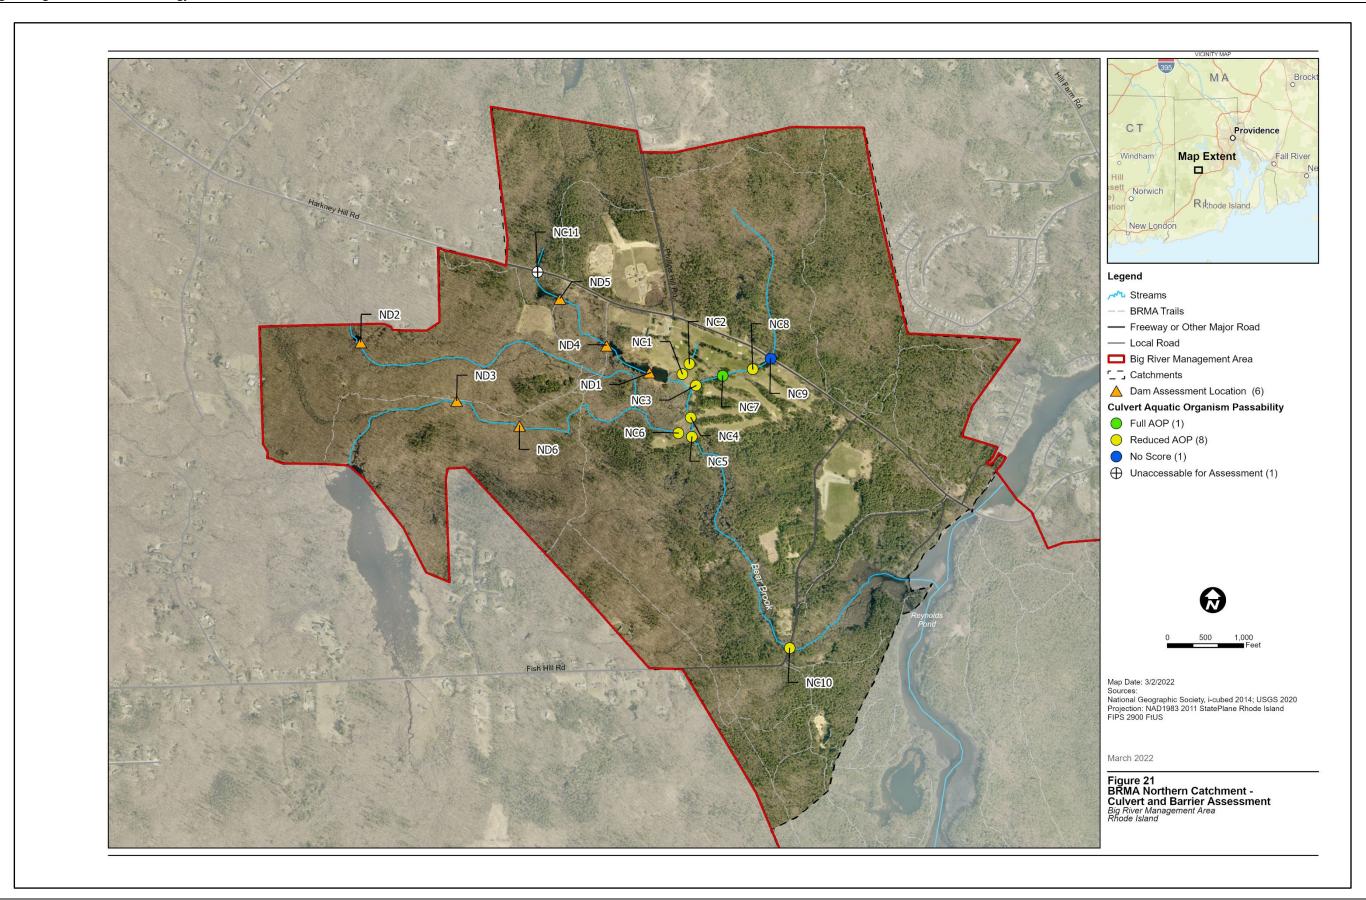
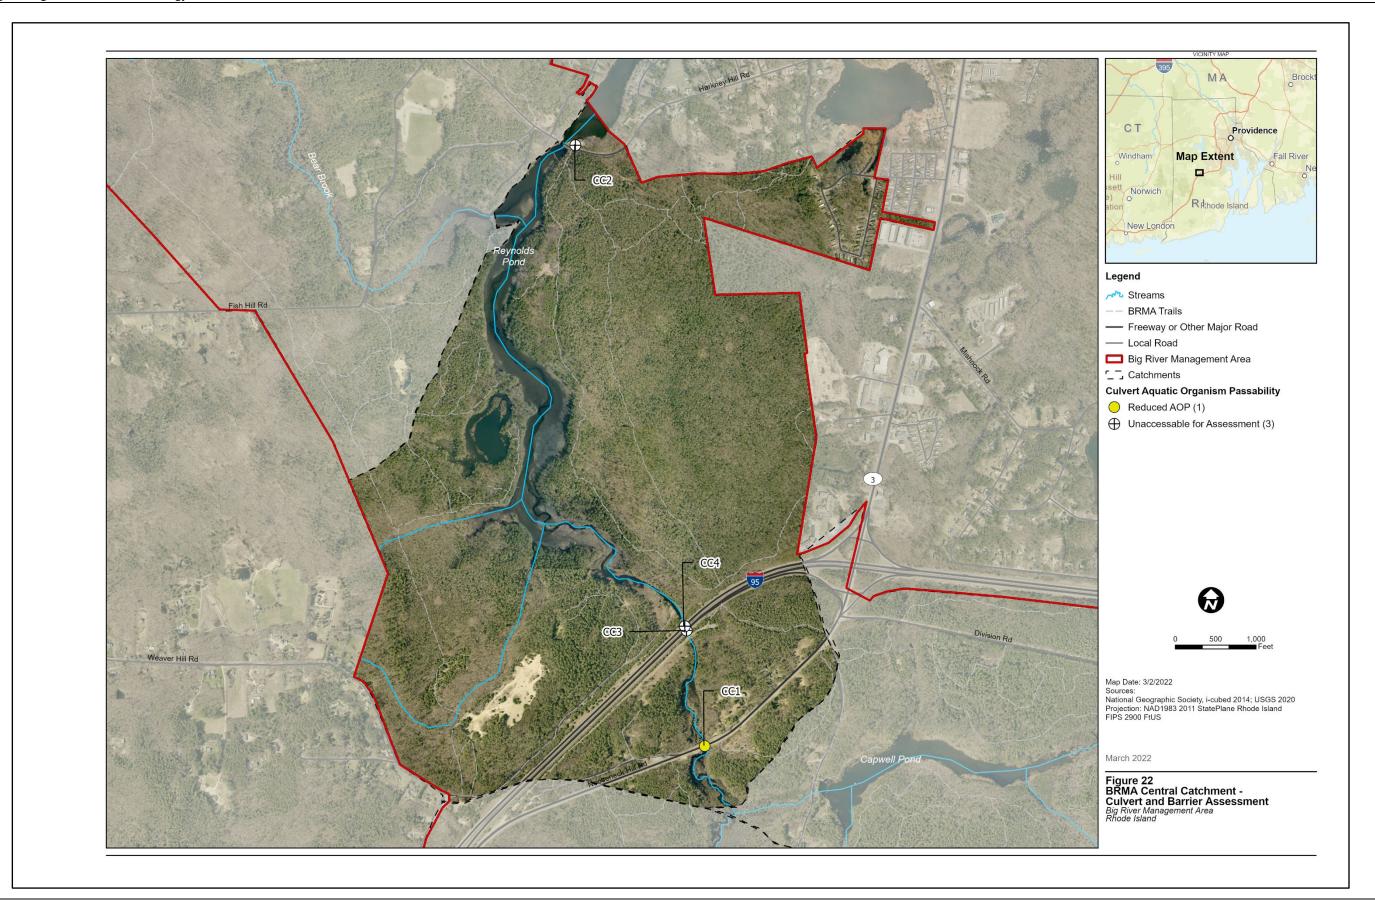
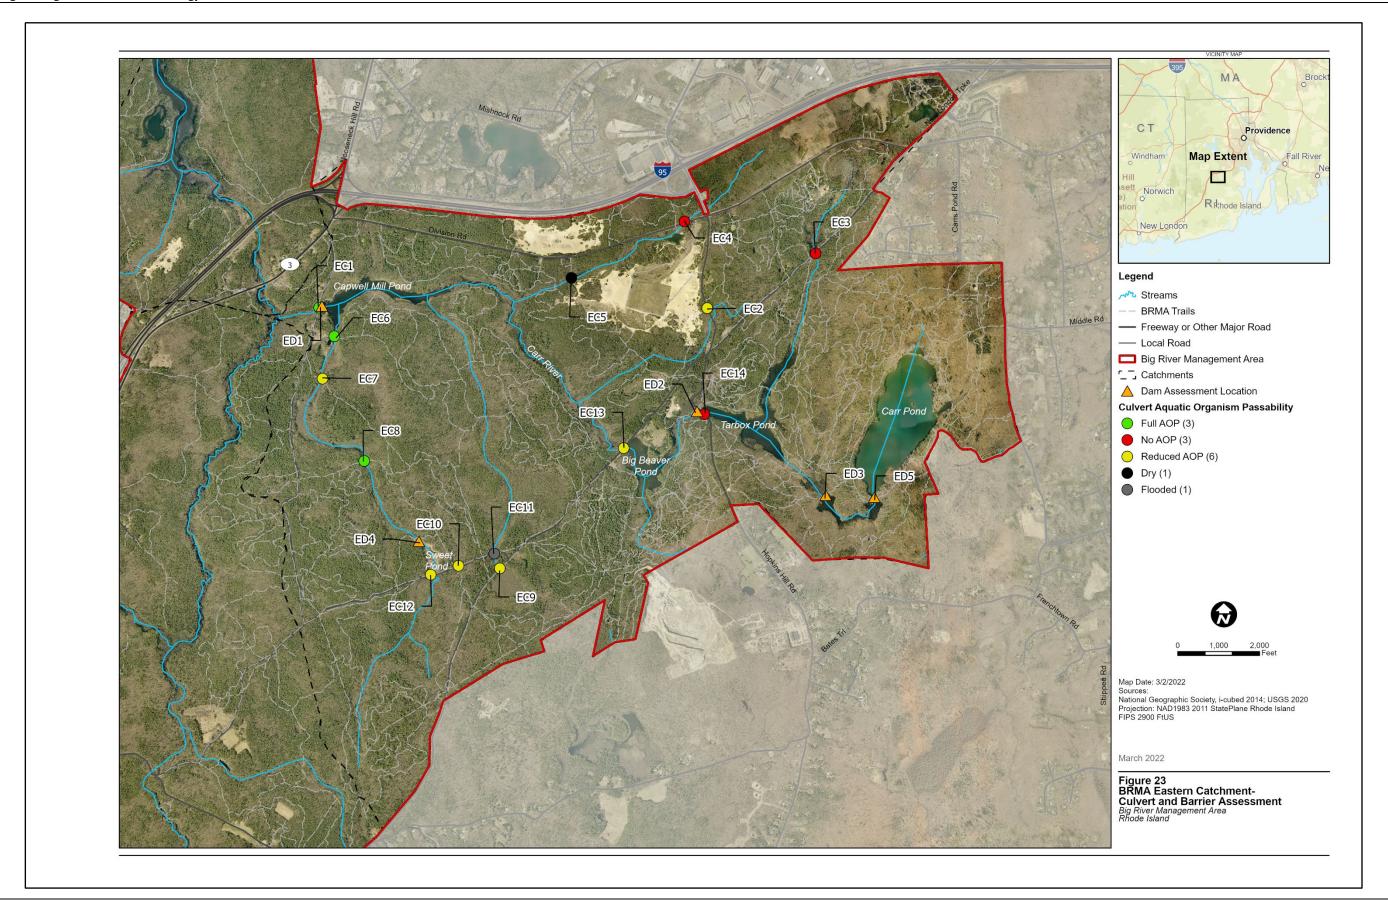
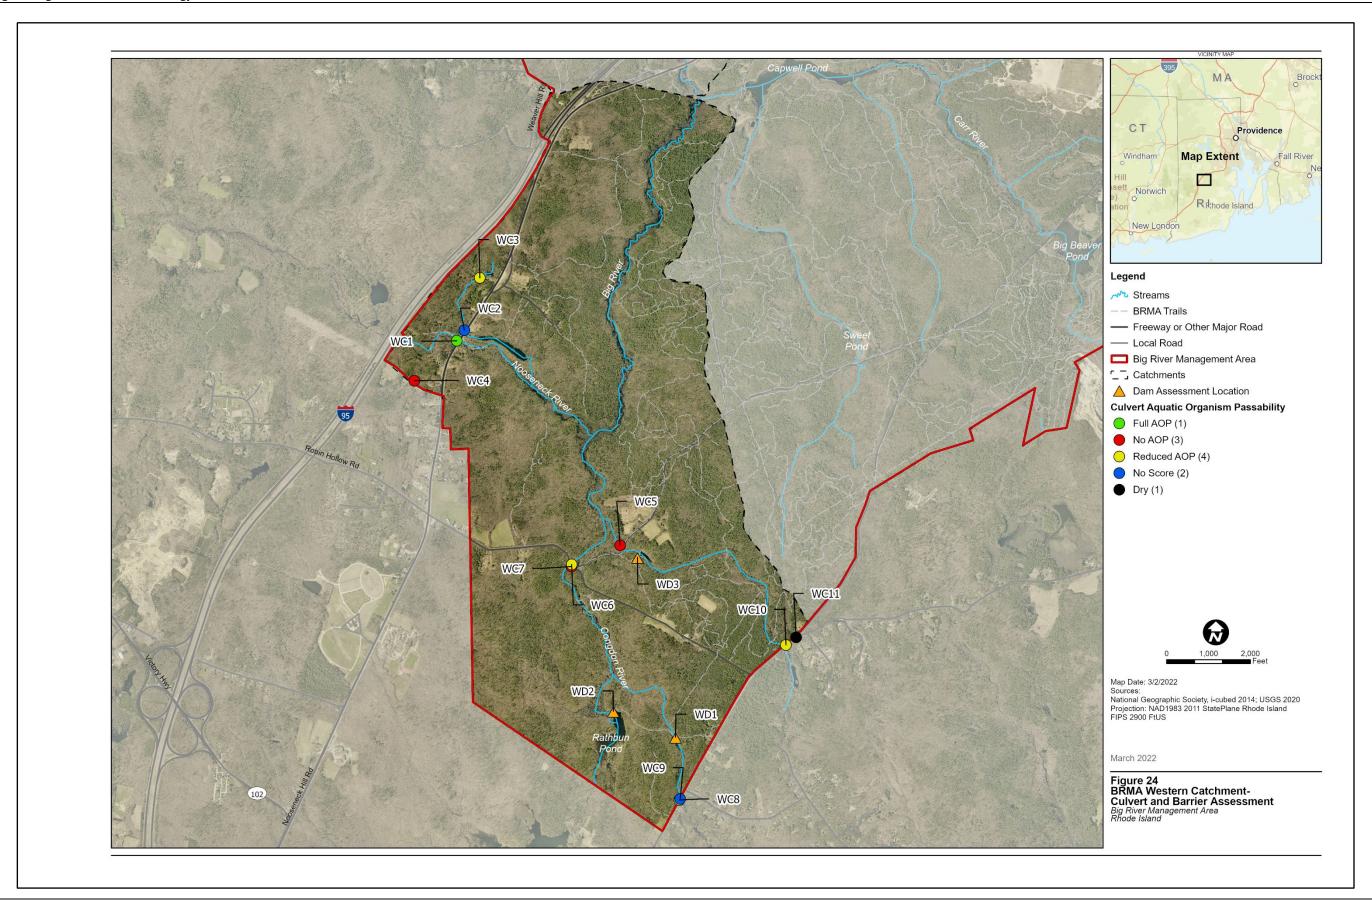
The results of culvert and dam assessments are tabulated in Tables 3-6 and 3-7. Locations of the culverts with corresponding AOP coarse screen scores and locations of the dams are shown on Figures 21-24.

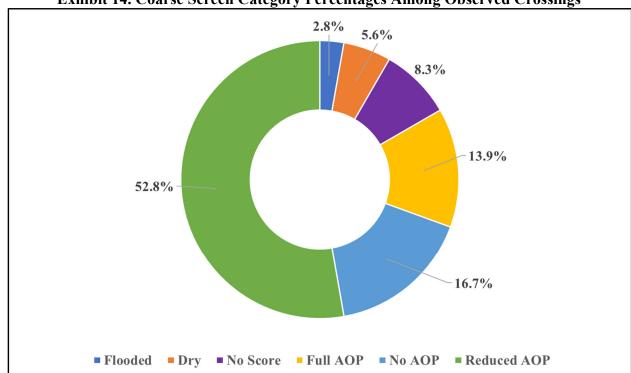
Exhibit 14. Coarse Screen Category Percentages Among Observed Crossings

Only five out of the forty culverts assessed in the BRMA were evaluated as having "Full AOP." Three culverts in the eastern catchment and three culverts in the western catchment were assessed as having "No AOP" (Figures 23 and 24). Nineteen culverts were assessed as "Reduced AOP" with minor barriers for aquatic organisms. The remaining six culverts did not receive AOP coarse screen scores because they were either dry, flooded, or not all parameters could be recorded due to culvert condition or location. Exhibit 14 depicts the breakdown of AOP scores for all assessed culverts.
